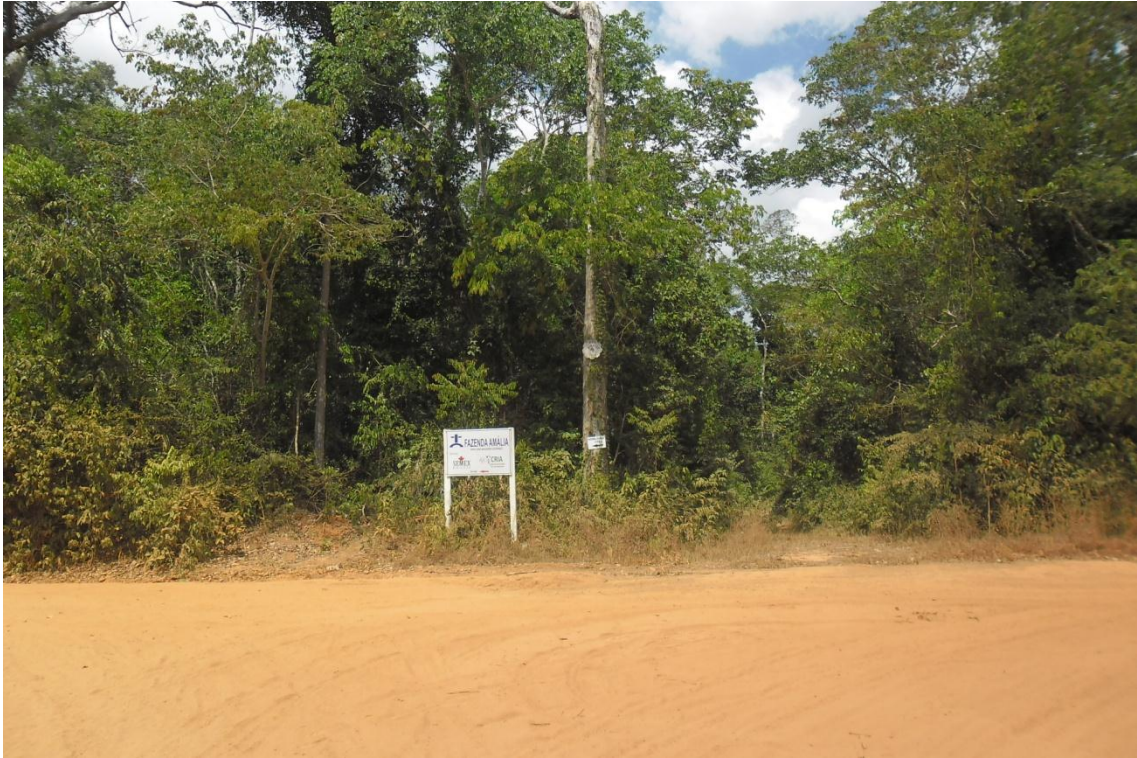
180	21L	337646,625	8715780,4	320,723	180-Inicio do trecho/Foto=5562
-----	-----	------------	-----------	---------	--------------------------------

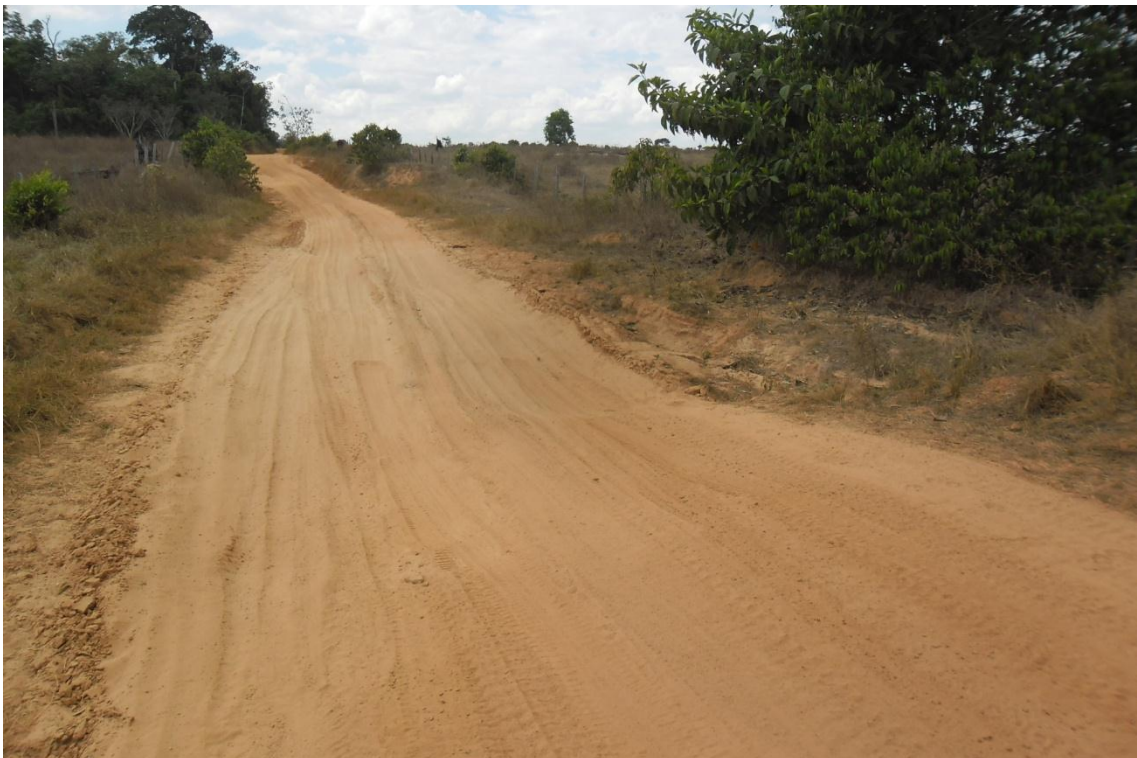
204	21L	333347,573	8715182,208	295,489	204-Largura 5.00m(Pasto Ponto Critico) Bueiro 80 Constr. Foto=5569
-----	-----	------------	-------------	---------	---

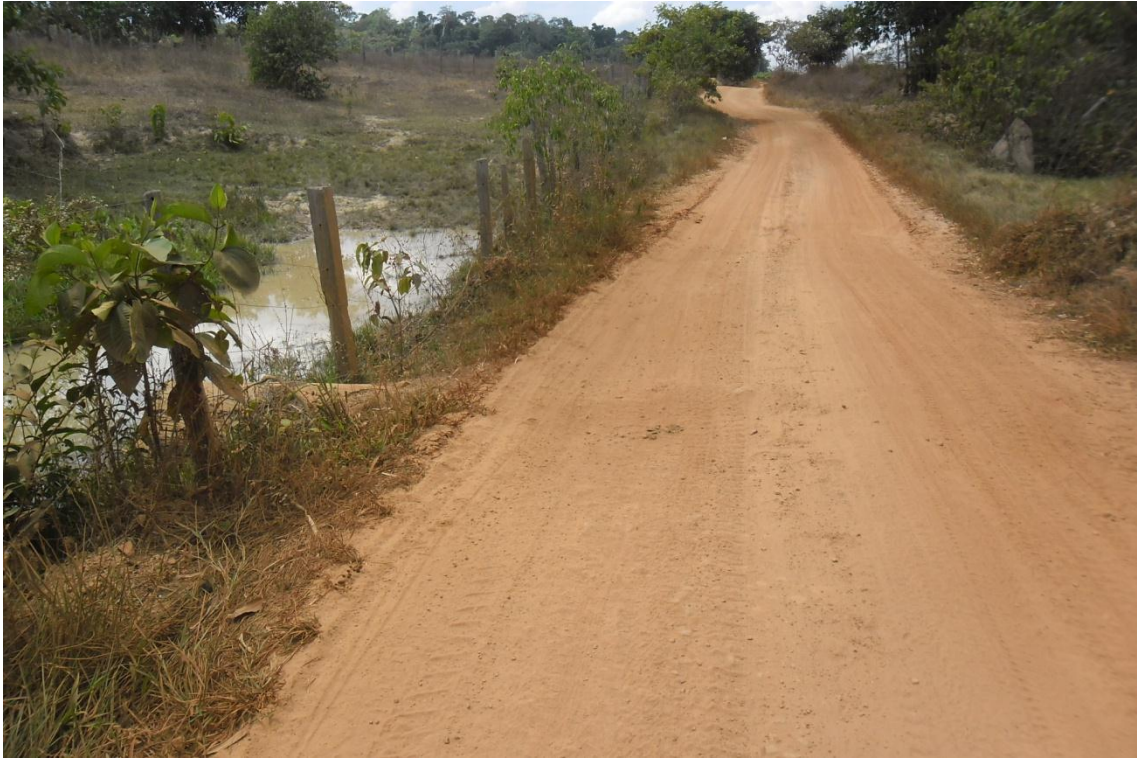
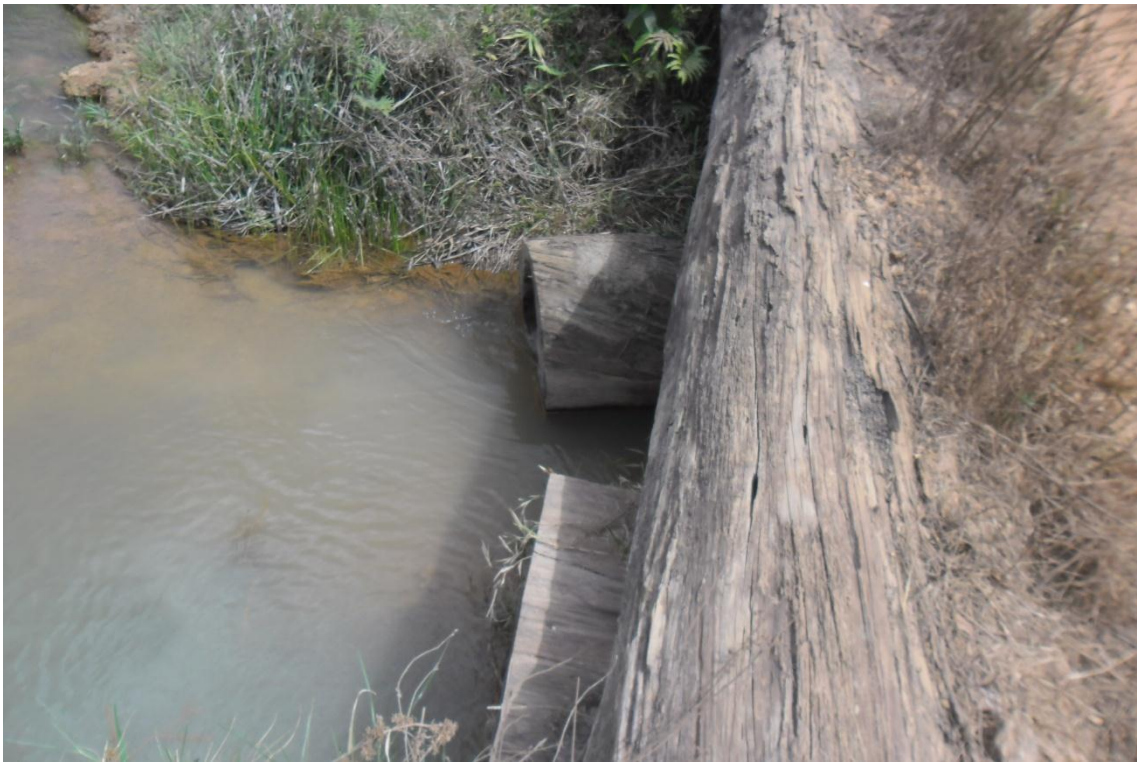
208	21L	332964,145	8715108,92	292,365	208-Pau Ocado Largura 5.00(Pasto) BDTC 80 Foto=5570/71
-----	-----	------------	------------	---------	---

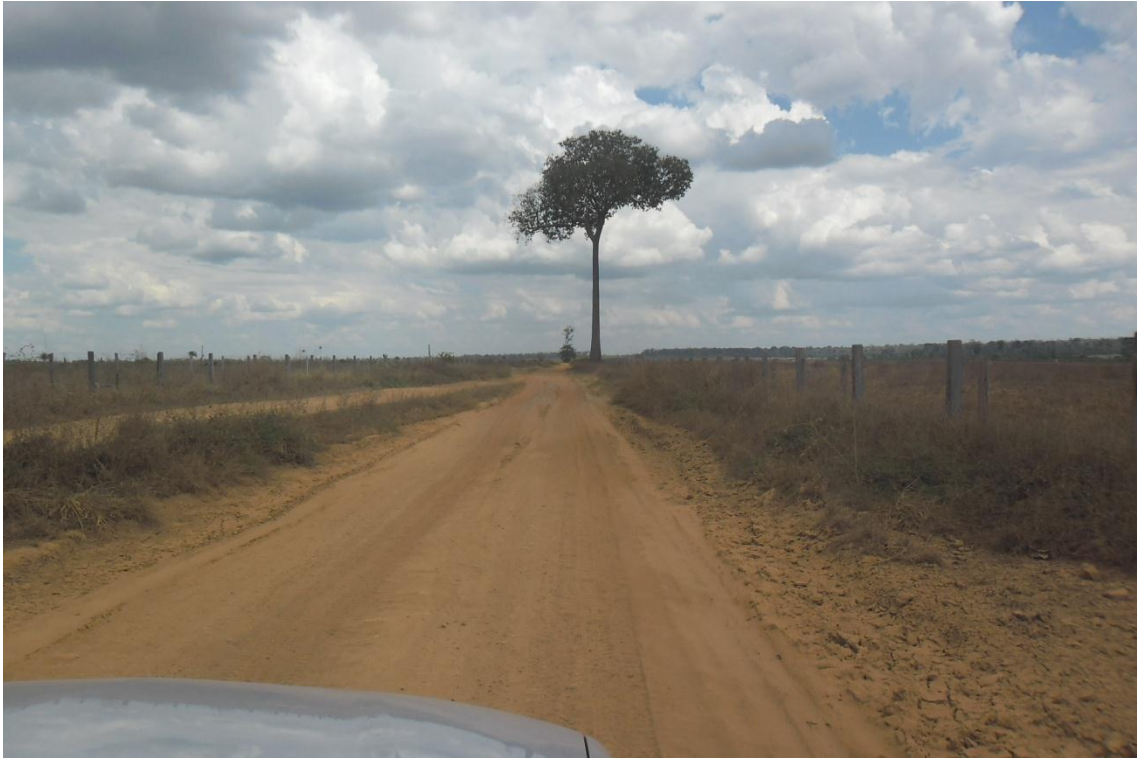
221	21L	330735,24	8714300,188	316,638	221-Largura 6.00m(Pasto) BD60 Foto=5572
------------	------------	-----------	-------------	---------	--

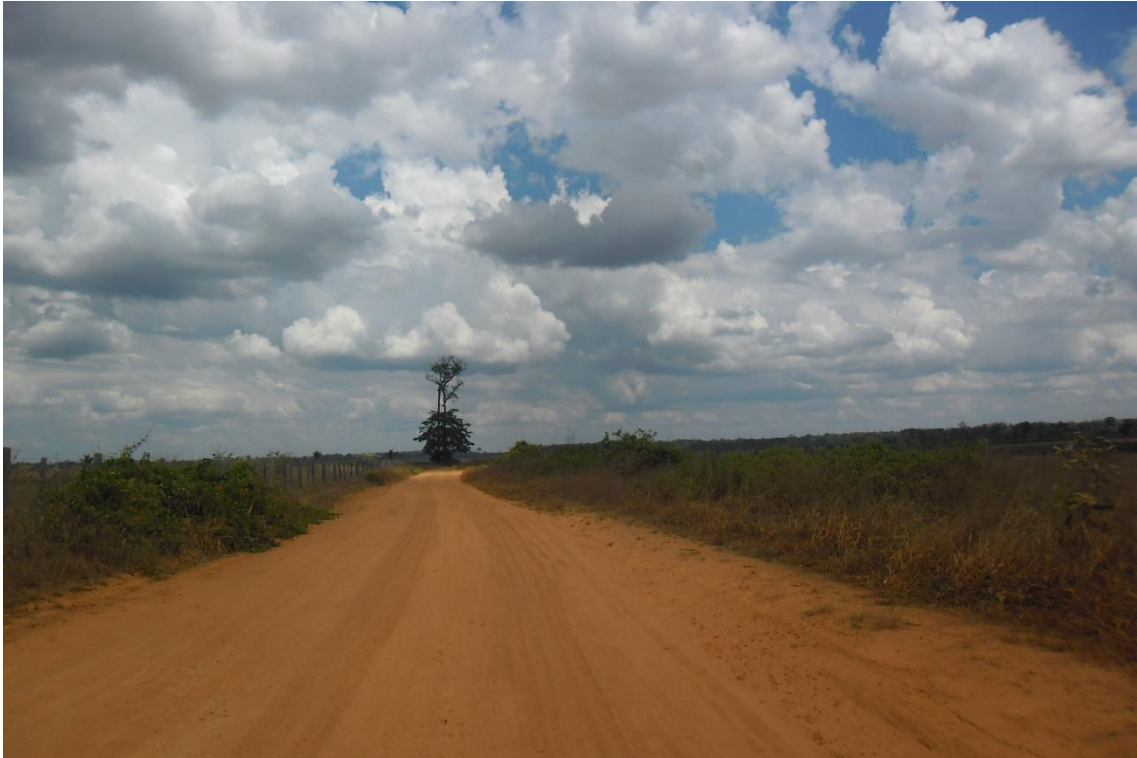
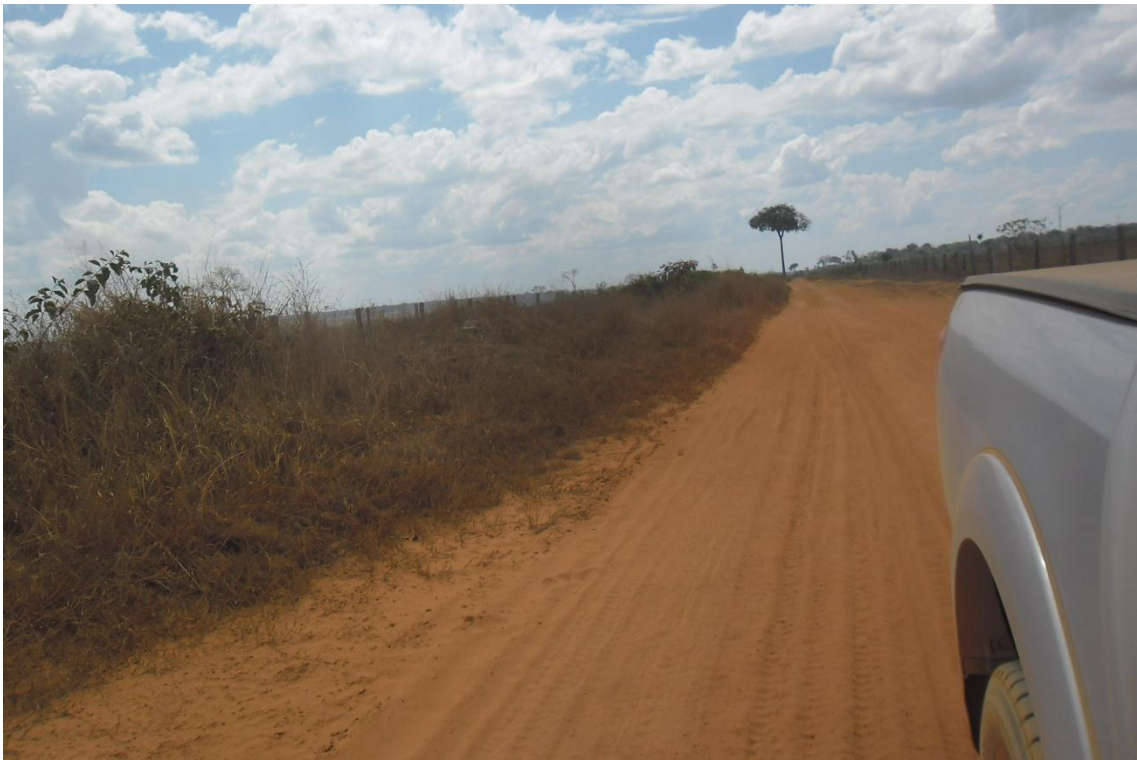
223	21L	330538,277	8713825,854	319,522	223-Largura 6.00m(Pasto) BD40 Foto=5573/74
------------	------------	------------	-------------	---------	---

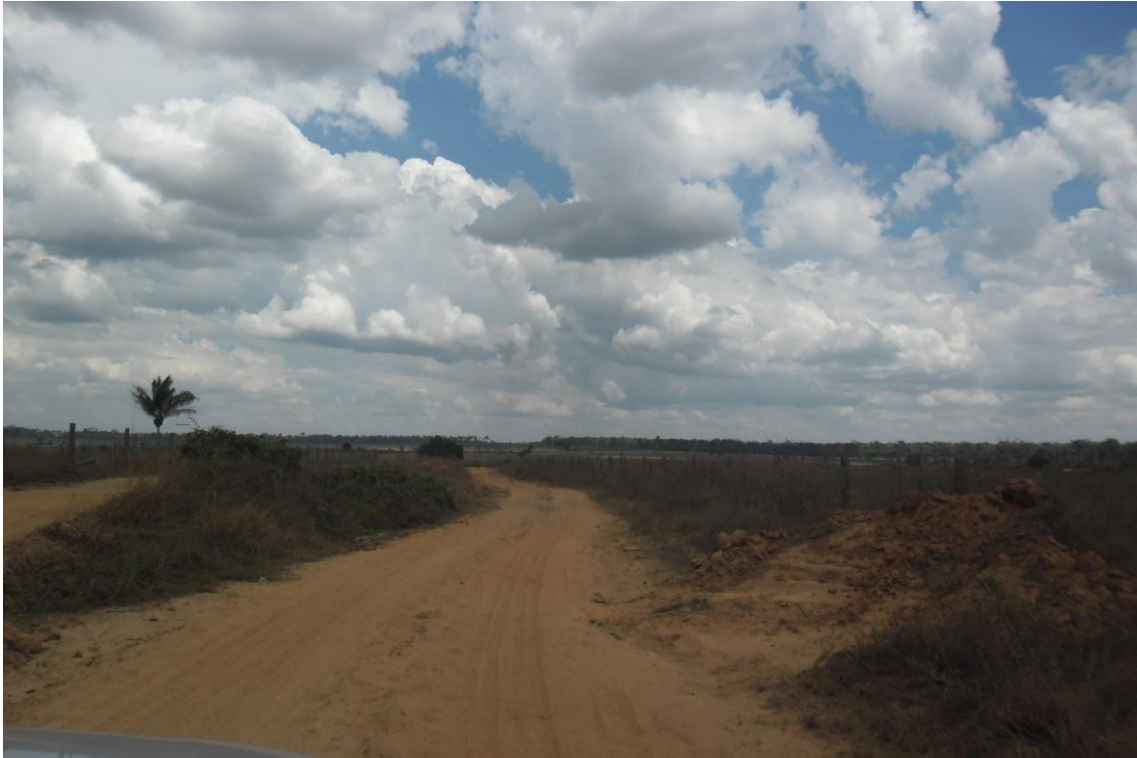
224	21L	330345,467	8713383,64	318,801	224-Largura 4.00m(Pasto)BD60 Ponto Critico Foto=5575
------------	------------	------------	------------	---------	---

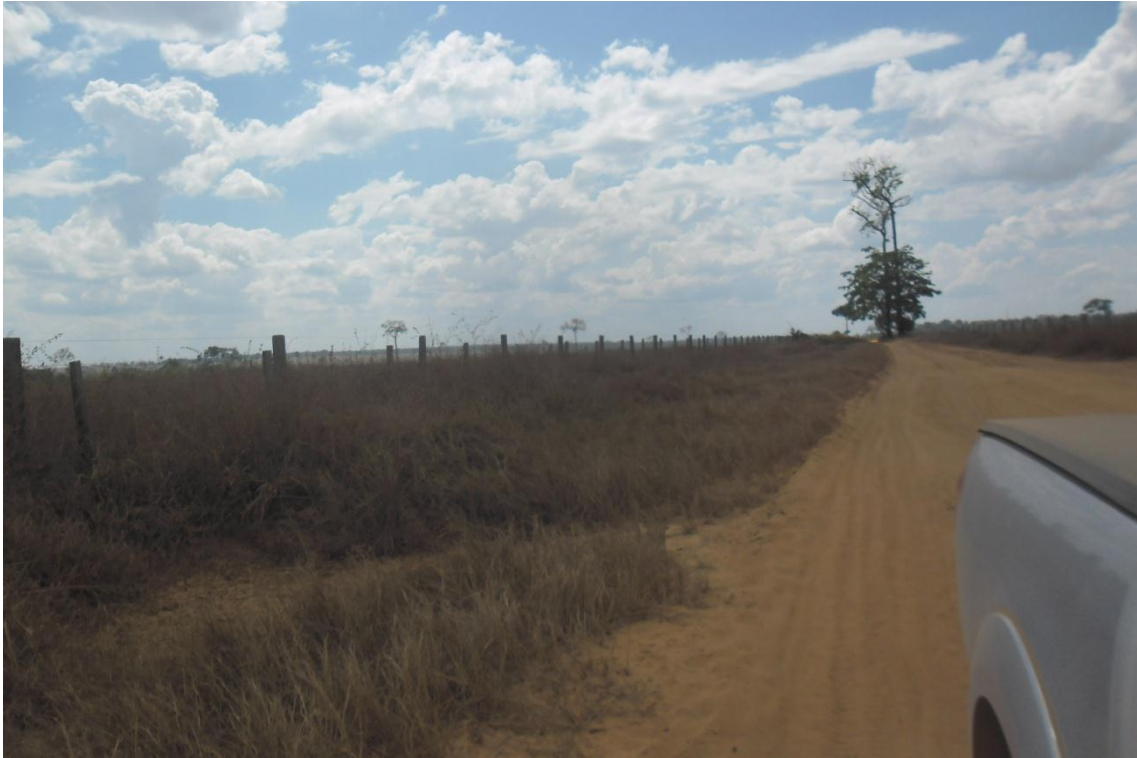
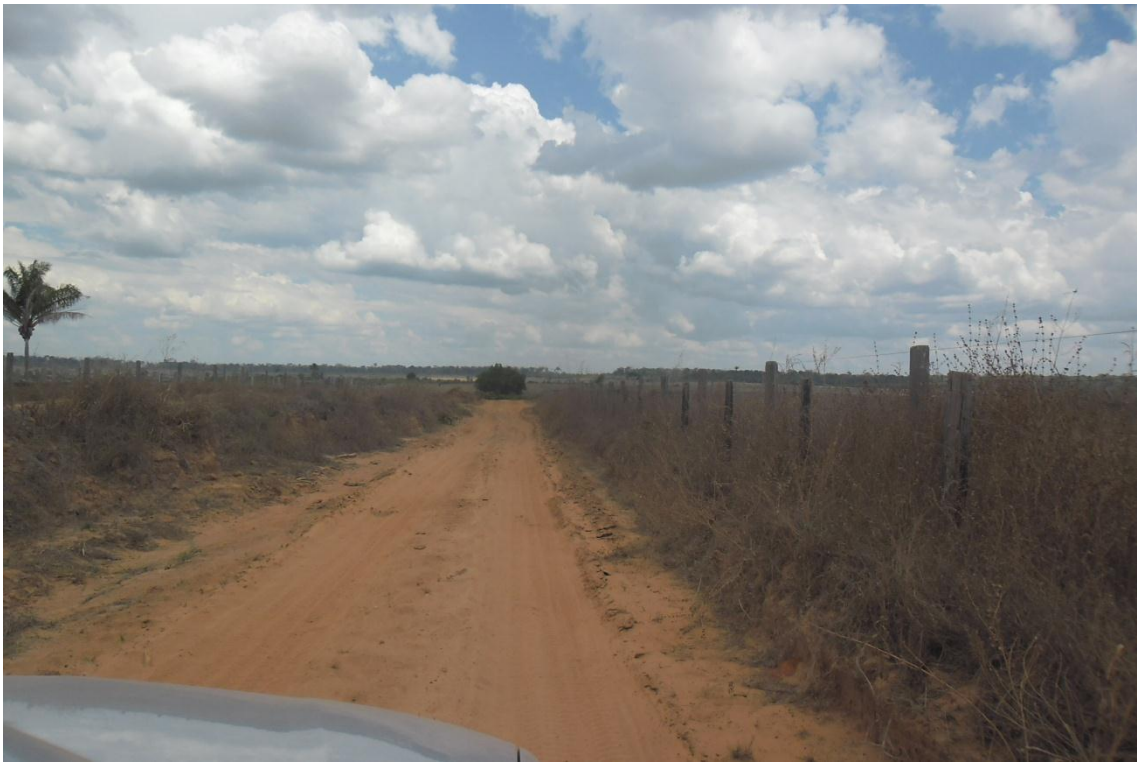
225	21L	330319,825	8713337,687	318,32	225-Largura 4.50m(Pasto) BD60 Po
-----	-----	------------	-------------	--------	----------------------------------

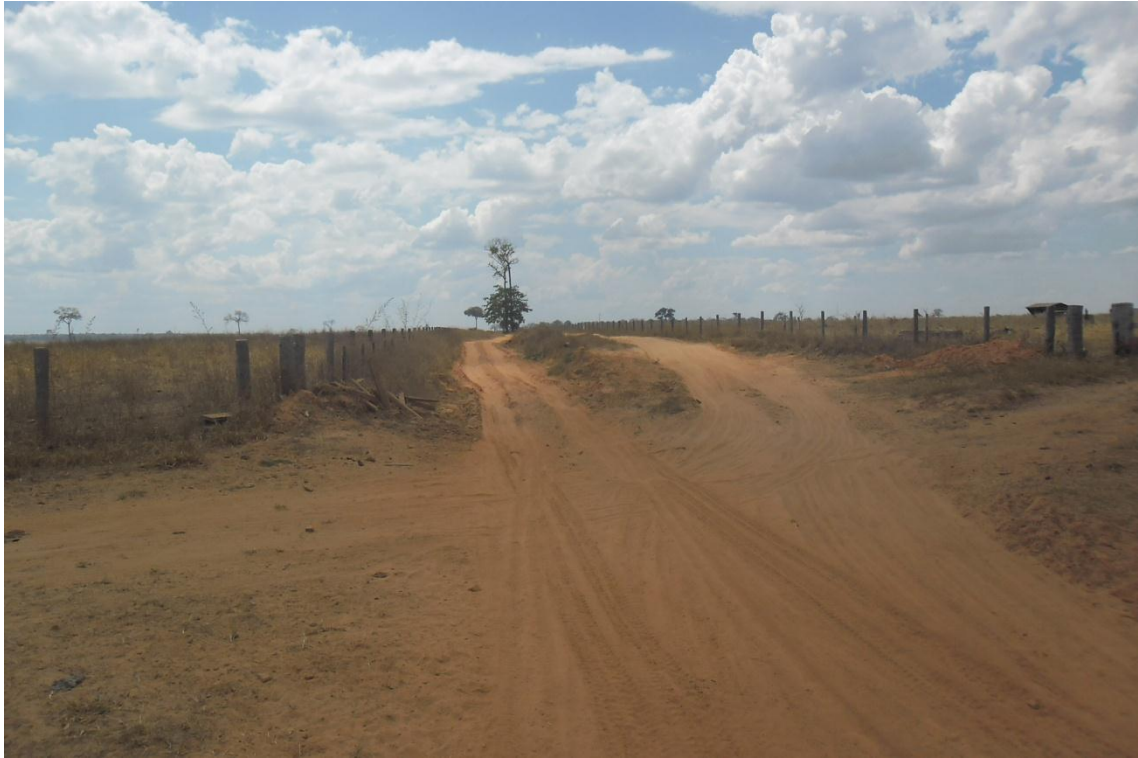
226	21L	330286,5	8713254,532	318,08	226-Largura 4.00m(Pasto) BD40 Ponto Critico Foto=5578
------------	------------	----------	-------------	--------	---

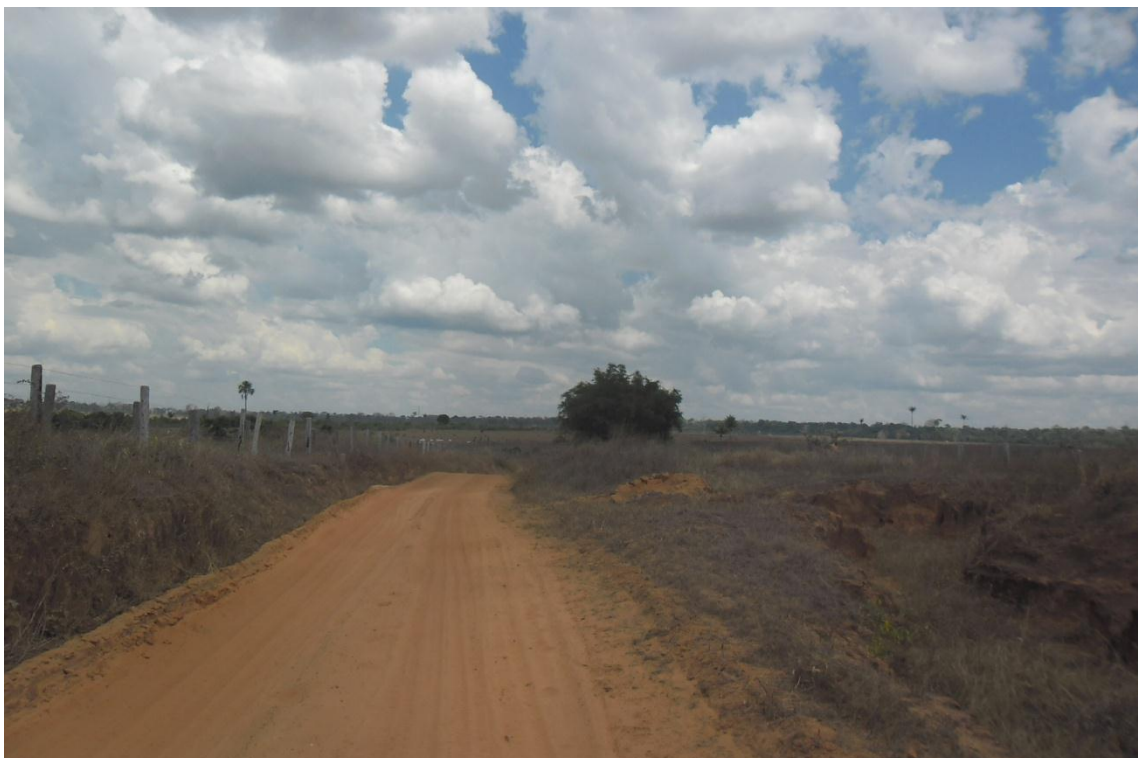
228	21L	330245,925	8713108,381	314,234	228-Largura 3.50m(Pasto) Erosão LD Regula +-40cm Foto=5579
------------	------------	------------	-------------	---------	--

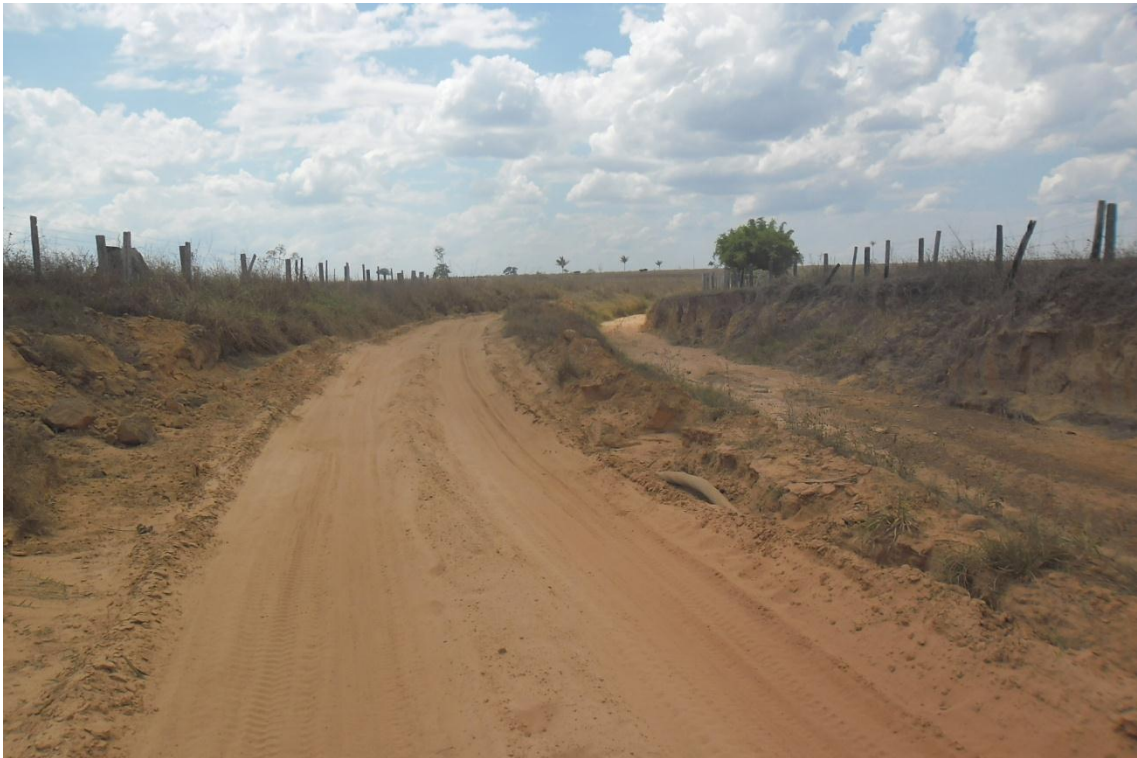
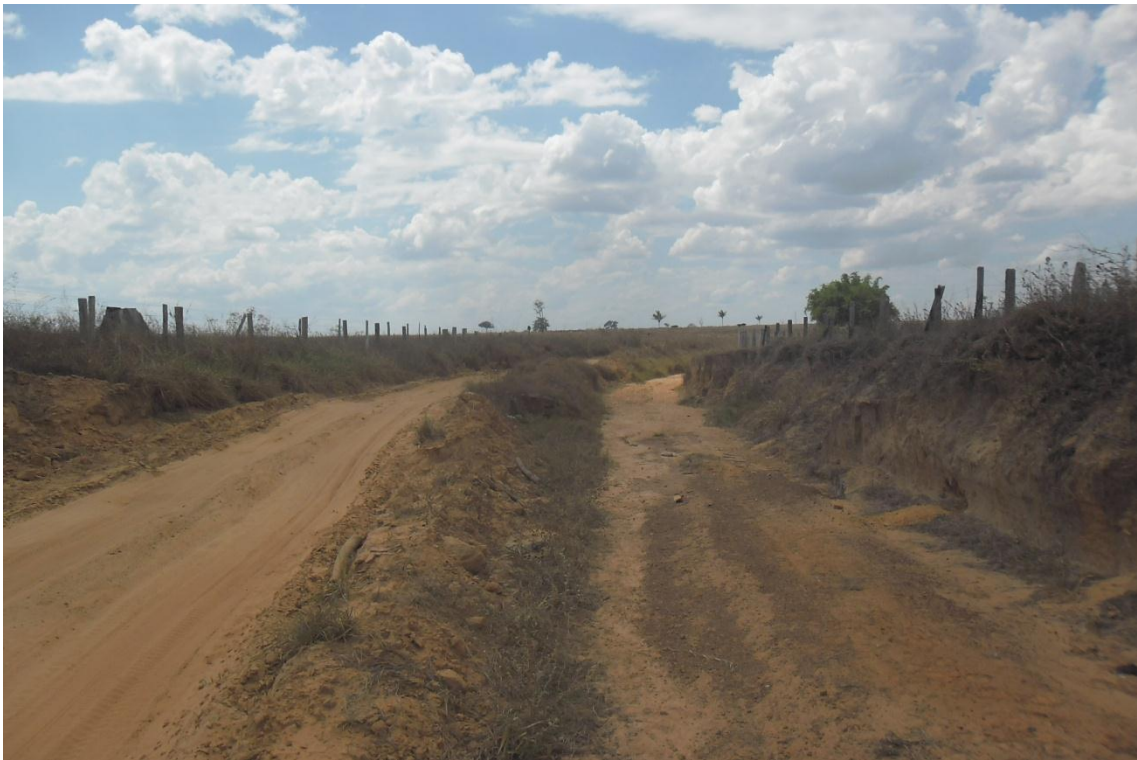
230	21L	330104,692	8712909,135	309,668	230-Largura 3.50m(Pasto) Areião BD60 Foto=5580/81
-----	-----	------------	-------------	---------	---

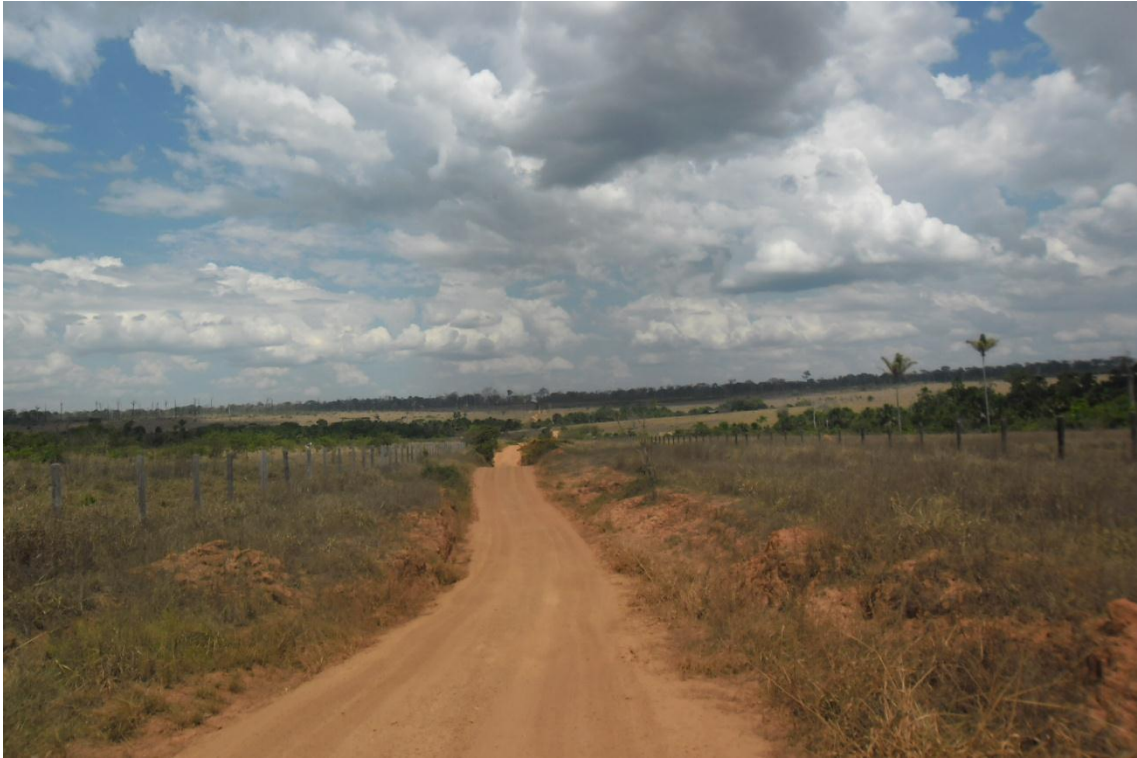
235	21L	329930,736	8712268,437	315,436	235-Largura 3.00m(Pasto) BD40 Foto=5582
------------	------------	------------	-------------	---------	--
